# Manhole Inspection Summary

Manhole # S31CC1005MH

Insp Date: **10/9/08 4:02 PM**

**Location** Address: **BEECHE AVE**

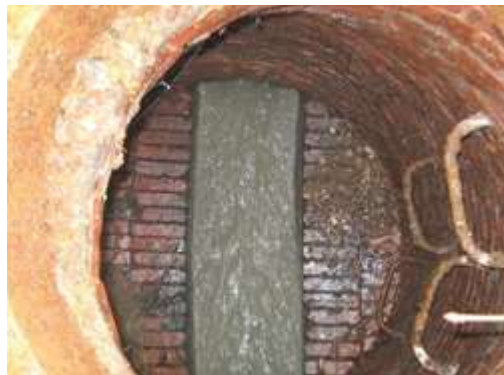
Top View

Corroded steps. Evidence of surcharge - Bench debris.

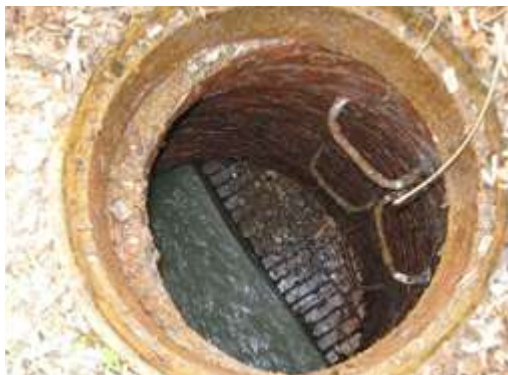
Defect

Frame offset. Adjustment, Corbel and Barrel infiltration.

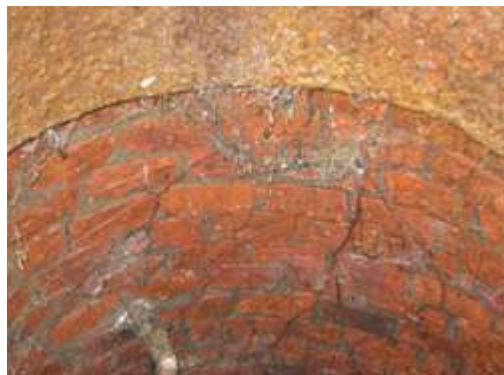
Defect

Adjustment and Corbel root intrusion and infiltration.

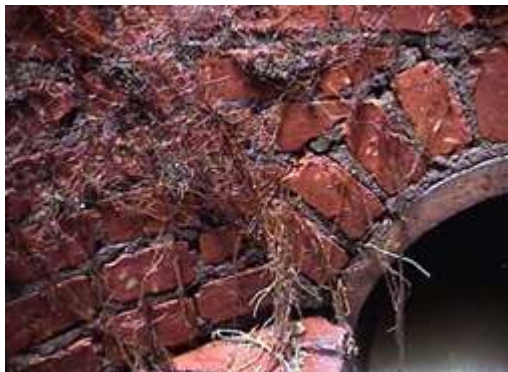
Defect

Barrel deterioration, root intrusion and infiltration.

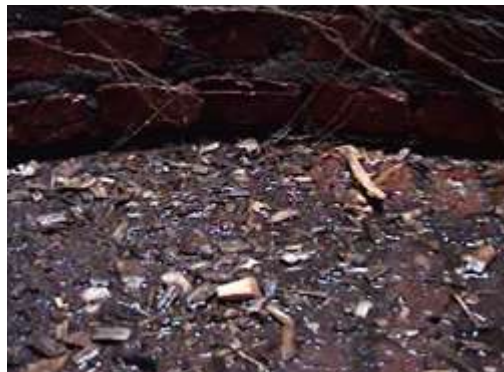
Defect

Barrel root intrusion and infiltration.

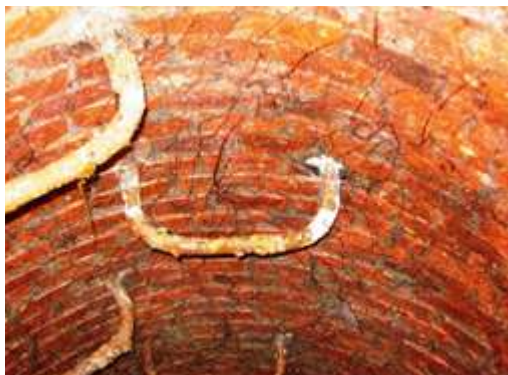
Defect

Corbel and Barrel root intrusion.

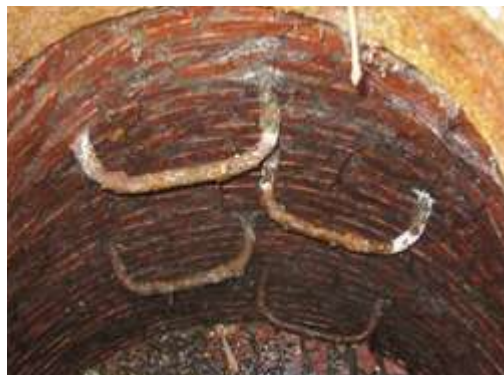
Defect

Adjustment, Corbel and Barrel root intrusion and infiltration.

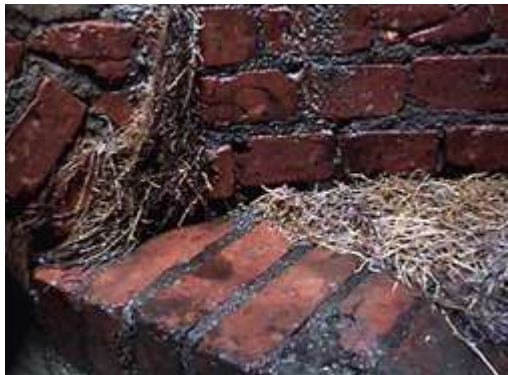
Defect

Barrel root intrusion and infiltration.

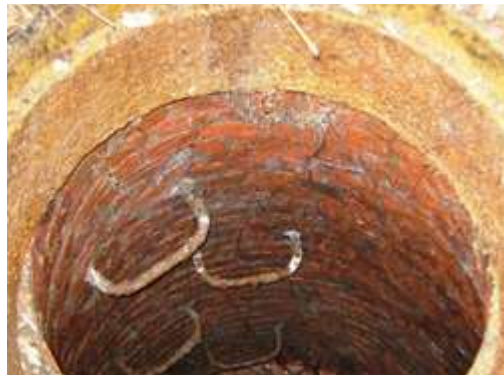
Defect

Adjustment, Corbel and Barrel root intrusion and infiltration.

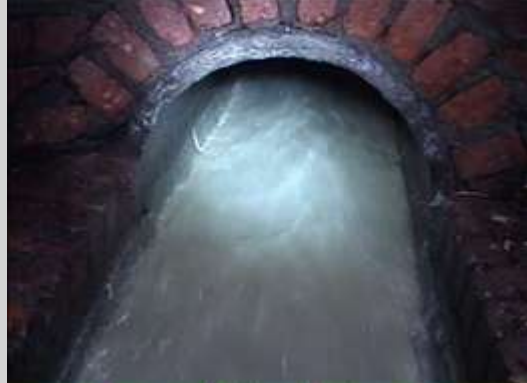
### 18 in. Circular Gravity Sewer Pipe Out @ 12 O'Clock

Infiltration: **Evidence** Pipe Seal Cond: **Unknown**

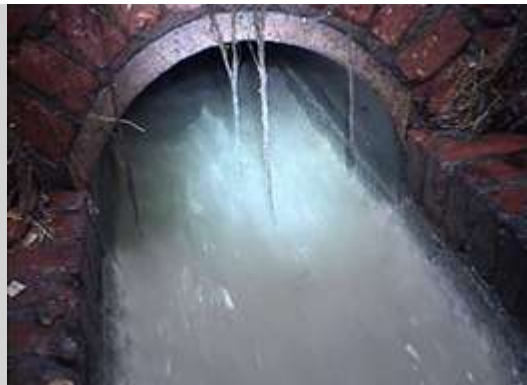
### 18 in. Circular Gravity Sewer Pipe In @ 6 O'Clock

Infiltration: **Evidence** Pipe Seal Cond: **Roots**

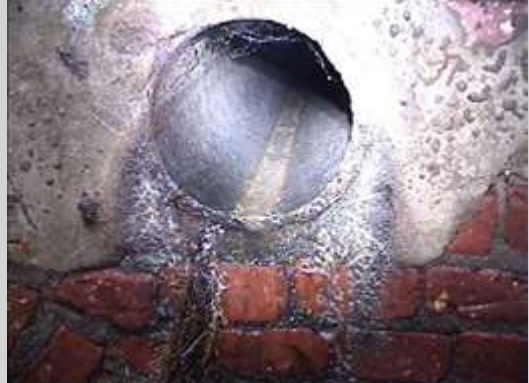
Pipe In @ 7 O'Clock

Infiltration: **Evidence**
